Loosen Zipfix: A Case Report

Case Study

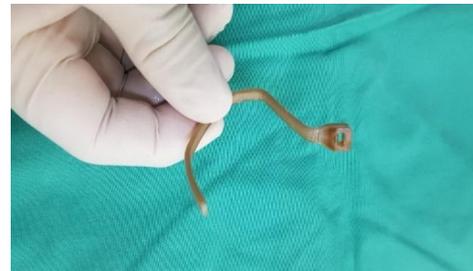
electively for zipfix removal under general anaesthesia. Intra-operative finding was the implant in the distal end of the sternum was loosened(implant which inserted into the locking head opened up).The other end, locking part of the zipfix was buried at the deep tissue close to the lateral edge of the sternum. The zipfix was easily removed without any complication and the sternum was healed. The patient was well post-procedure and was discharged the next day.

Fig. 1. Sternal zipfix after removal

For this case, the extracted zipfix were reported to the company. Based on the company's analysis, a minor mark was seen on the ridge of the implant. A small amount of wear was observed on the latch within the locking mechanism. A functional test could not be performed, as the returned part was too small to reinsert into the locking mechanism to test the tightening ability of the implant. The material became too stiff to bend appropriately into the mechanism. This could be due to use within the patient's body. No other design defect was detected. Based on the analysis, no manufacturing defect was detected.

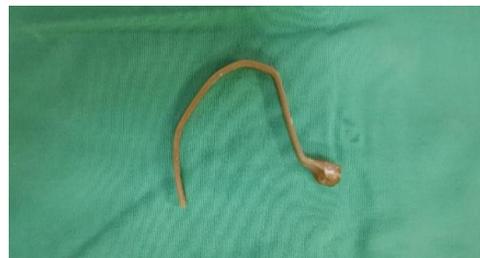
Fig. 2. The material became stiff to bend appropriately into the mechanism

Wrong technique may result into failure of the implant. We were strictly adhering to the above technique. However, the locking mechanism of the device had failed most probably due to the wear and tear component.
